The Benefits of Pump Restoration and Coating - Part 2

[Joe Evans, Ph.D](#)

The Restoration Process - Before and After

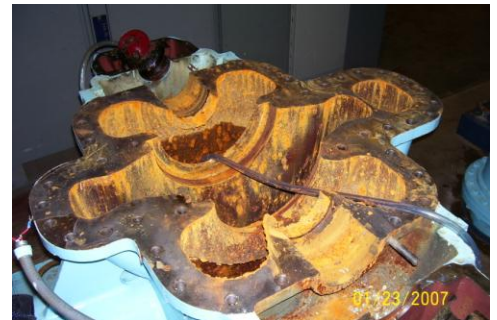
Figure 1 shows a typical pump's internal condition prior to sandblasting. This particular pump is a 600 hp model that was installed in the mid 1980's. As shown, the interior exhibits both surface corrosion and tuberculation. Figure 2 shows a better view of the tuberculation. In certain areas of the casing and cover, tubers were larger than one half inch.

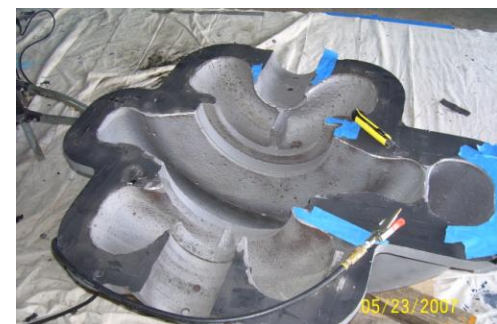
Figure 3 shows the interior of the pump after sandblasting. After sandblasting the surface was evaluated to determine if application of metal filler was required prior to coating. This particular pump exhibited a significant amount of surface pitting

and those pits were filled prior to the coating process. Figure 4 shows the same pump after application of the metal filler and two coats ceramic filled, epoxy coating.
