## Dezincification - Another Type of Erosion

[Joe Evans, Ph.D](#)

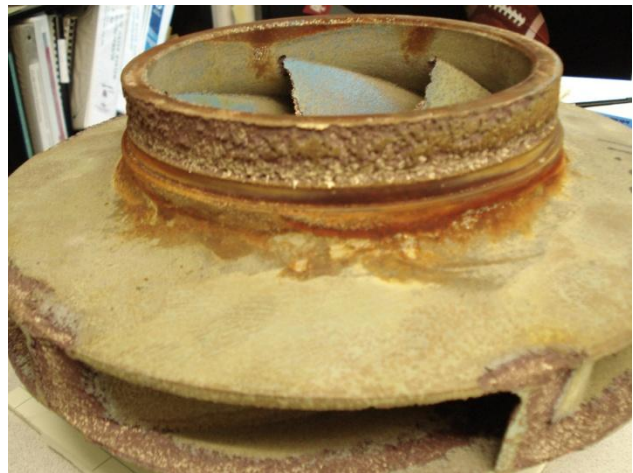
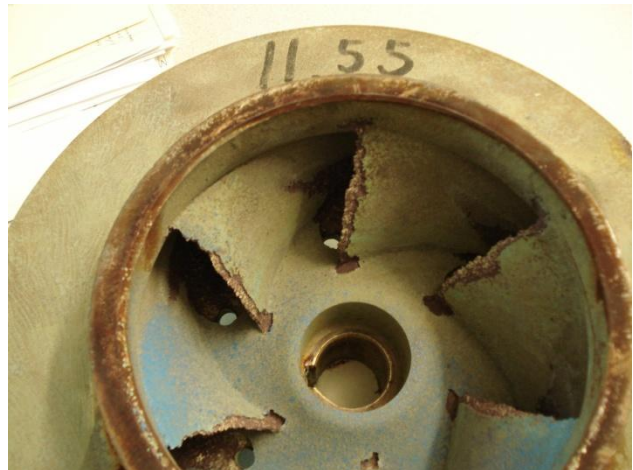
In June, I received a call from an engineer with the Vancouver, Washington water department. They had a bearing failure in one of their close coupled, end suction pumps and, upon disassembly, noticed what appeared to be moderate to severe cavitation damage on the silicon bronze impeller. It had been in service for about two years. He wanted to know if I knew what might be causing the cavitation. I received several photos (on the right) and upon first glance it did look like recirculation cavitation. There was erosion on the high pressure side of the vane entries and exits and along the surface of the eye that interfaces with the wear ring.

After further study I began to see some unusual characteristics of the erosion. It looked more like chemical erosion rather than cavitation erosion. When I learned that the pump was running at 95% of BEP flow and that the suction pressure was 70 PSI, cavitation was ruled out.

The idea of traditional chemical erosion did not last long either. When I asked if the pump was in a process line or near their chlorine injection system, I was told it was just a booster pump that provided finished drinking water to a nearby subdivision. The residual chlorine averaged about one part per million. After consulting with some of my associates at PumpTech, we found the right answer - - dezincification.

brass and bronze alloys and normally occurs when the zinc content is 15% or greater. The result is a porous copper material of reduced strength. Often the first sign of dezincification is a reduction in hydraulic performance. It was first detected in high zinc impellers used in salt water applications and high chlorine applications such as swimming pools. Studies have also shown that chlorine concentrations as low as two parts per million can cause dezincification. It can also be caused by conditions that give rise to high dissolved oxygen or carbon dioxide concentrations.

For over fifty years SAE-40 bronze was the most common alloy used for impellers. It was discontinued by most US foundries in the mid nineties due to its 5% lead content. Due to its low zinc content ( 4 - 6%), dezincification did not occur. Silicon bronze or brass impellers which contain 16% or more zinc are prone to dezincification. Some manufacturers have reduced the zinc content to just 12% which reduces the potential for dezincification. Alloys that can completely eliminate dezincification include nickel, aluminum bronze and tin bronze. 304 stainless steel is also an option in potentially troublesome applications. I did some price checking and found that a nickel, aluminum bronze impeller costs about 10% more than silicon bronze. 304 stainless steel costs about 20% more.

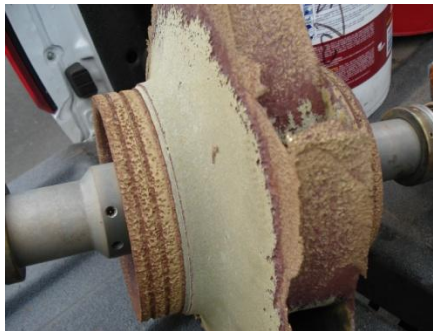
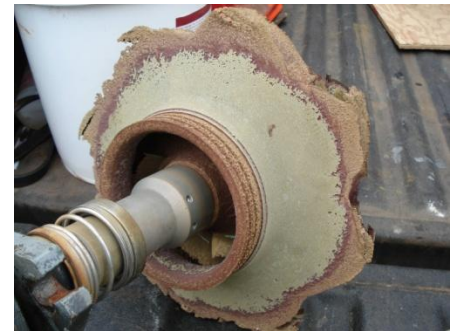
If you need to see another example of dezincification, take a look at these photos. This impeller is also silicon bronze and was installed in a split case booster pump at the same facility in Vancouver. This pump had been in service for about five years. They have since upgraded these impellers to nickel, aluminum bronze.
