Why the Left Can Be Dangerous - A Conservative's Viewpoint

[Joe Evans, Ph.D](#)

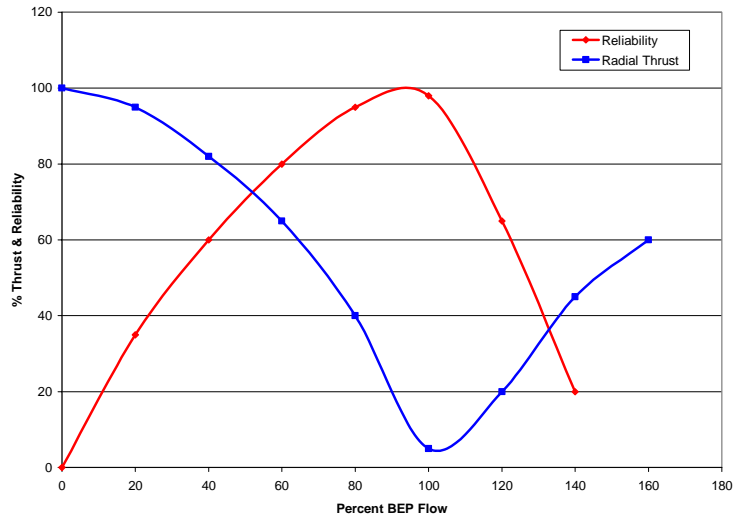
Realiability Versus Radial Thrust

pass solid material. Figure 1 shows some API data that compares pump reliability to the level of radial thrust. Radial thrust is lowest at BEP and increases to its maximum at shut off while pump reliability is greatest at BEP and reaches its minimum at shut off. Note that reliability decreases rapidly to the left of the intersection of the two curves (approximately 50% of BEP).

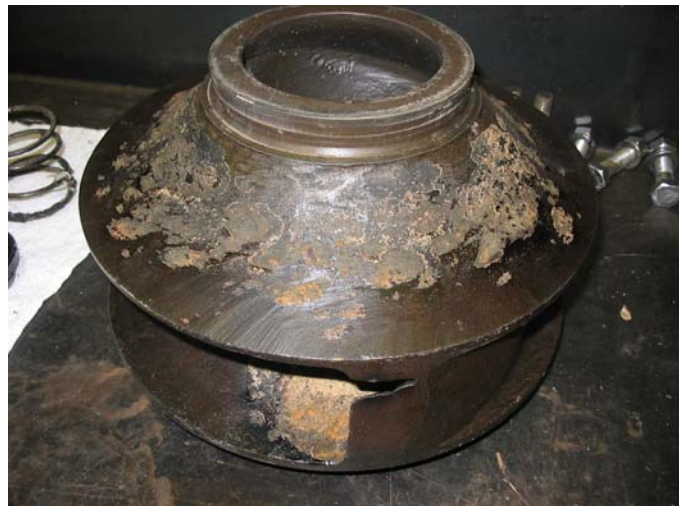
Lets take a look at a real life example of what can happen when a pump is misapplied and ends up operating well to the left of BEP. A 4" non-clog with an 11.5" impeller has a manufacturer approved minimum flow of 250 GPM. The application specified a flow of 600 GPM @ 125' - - which is about 70% of BEP flow. Unfortunately a design error resulted in a head miscalculation. At start up, a flow meter indicated a flow of just 340 GPM - - or about 40% of BEP. Since the specified flow of 600 GPM would not be needed until build out was complete, the sewer district decided to allow the pump to remain installed. It was pulled approximately 13 months later for inspection.

Figure 2 shows the impeller that was removed from this pump during inspection. The front shroud exhibited severe erosion due to cavitation that arose from excessive recirculation from the vane exits back to the suction. Erosion was also found on the volute wear ring. In addition, severe erosion was found on the inside of the shrouds and the low pressure side of the vanes at the vane exit. This

cavitation was due to discharge recirculation. Both forms of recirculation and the resulting cavitation were caused by operation too far to left side of the curve even though the actual flow was above the approved minimum.
